# Fluorescent Aerosol Screening Test (FAST) Test Report

RTI Project Number: 0212534.112

January 7, 2015

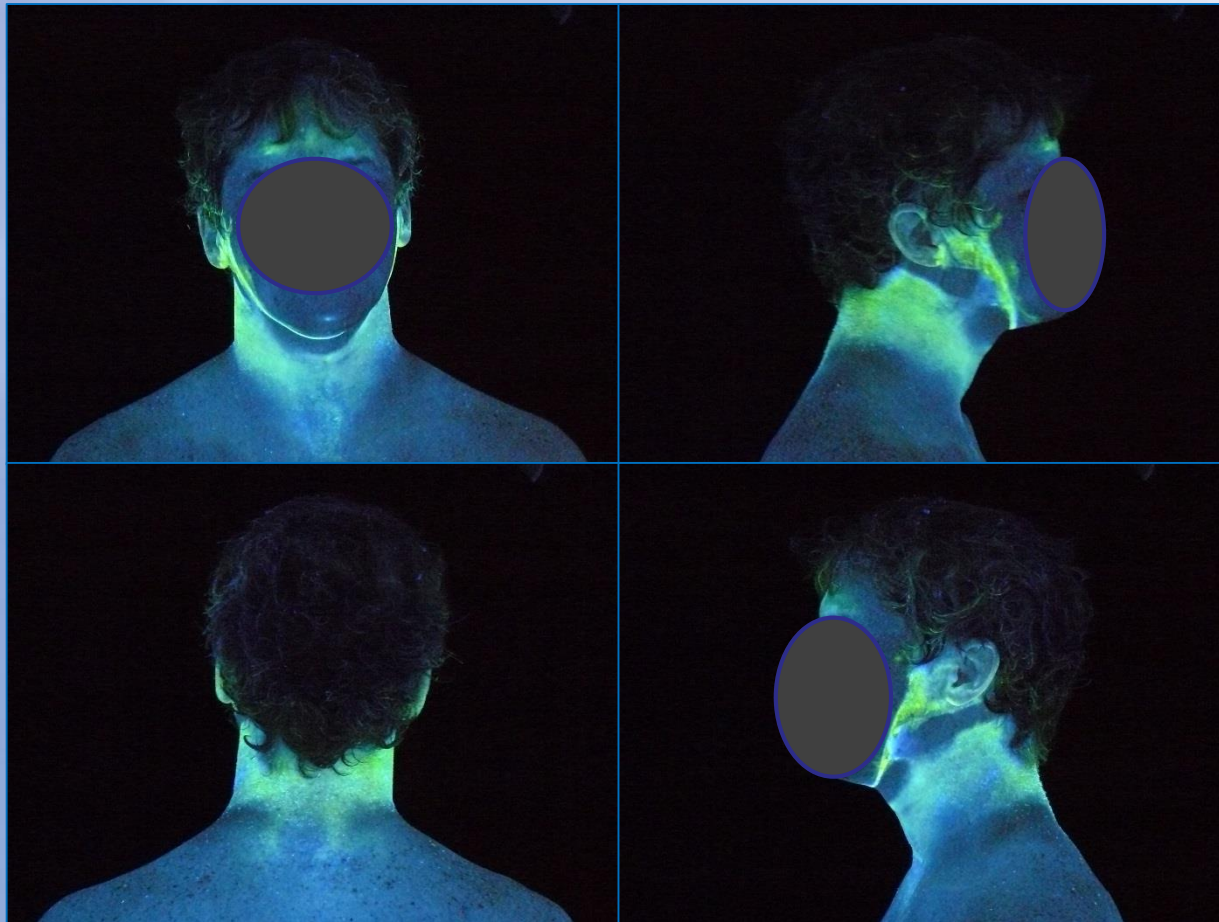
## UV Photos: Head and Neck (Test # 2225, TP #7)

There were very heavy aerosol deposits on the neck, cheeks, ears, and hair due to penetration through the hood. The dark bands below the ears were relatively clean areas that were covered by the mask straps.

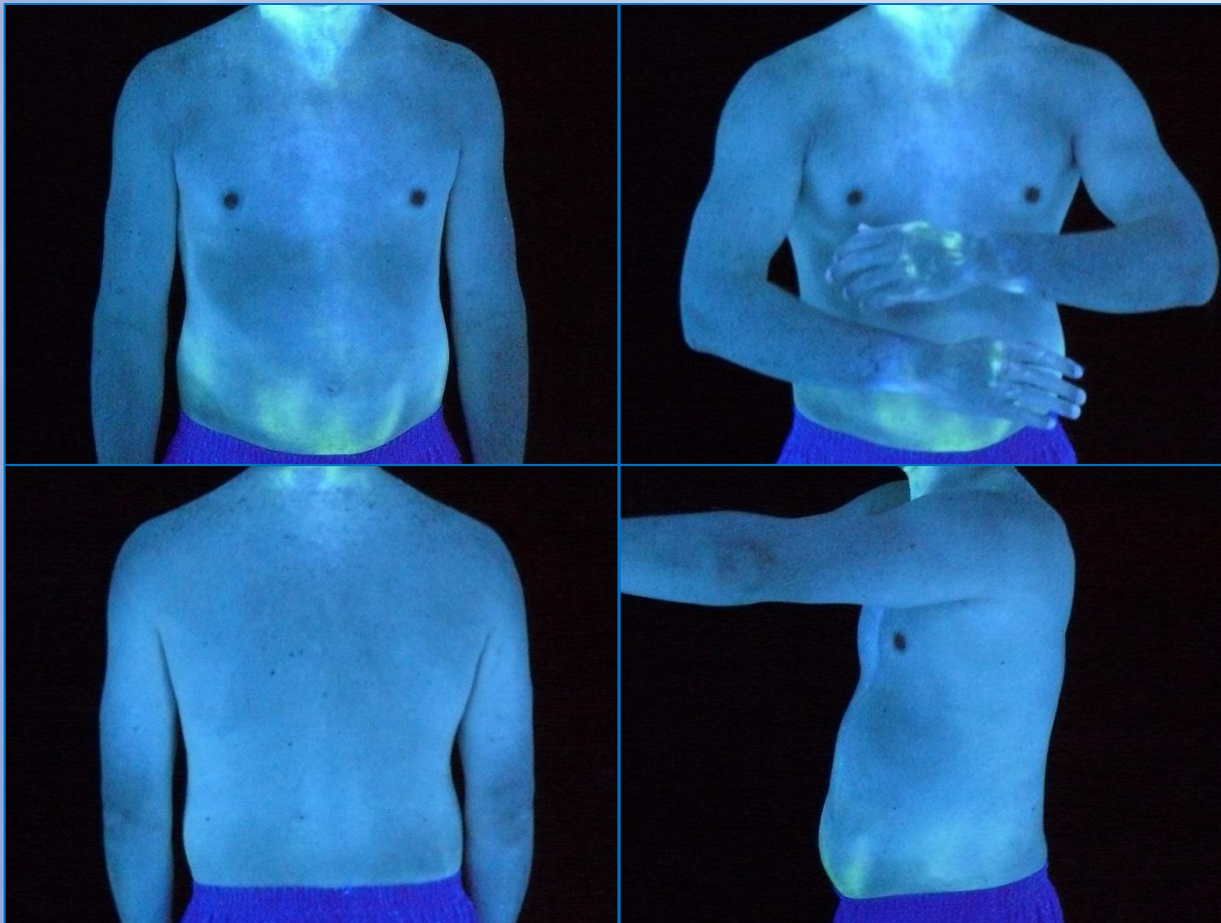
## UV Photos: Torso and Arms (Test # 2225, TP #7)

The lower front torso showed moderate to heavy aerosol deposits, and the location and pattern suggest infiltration through the coat-trouser interface. The bright spots on the hands and wrists could have been due to aerosol penetration, an artifact from doffing, or a combination of both.

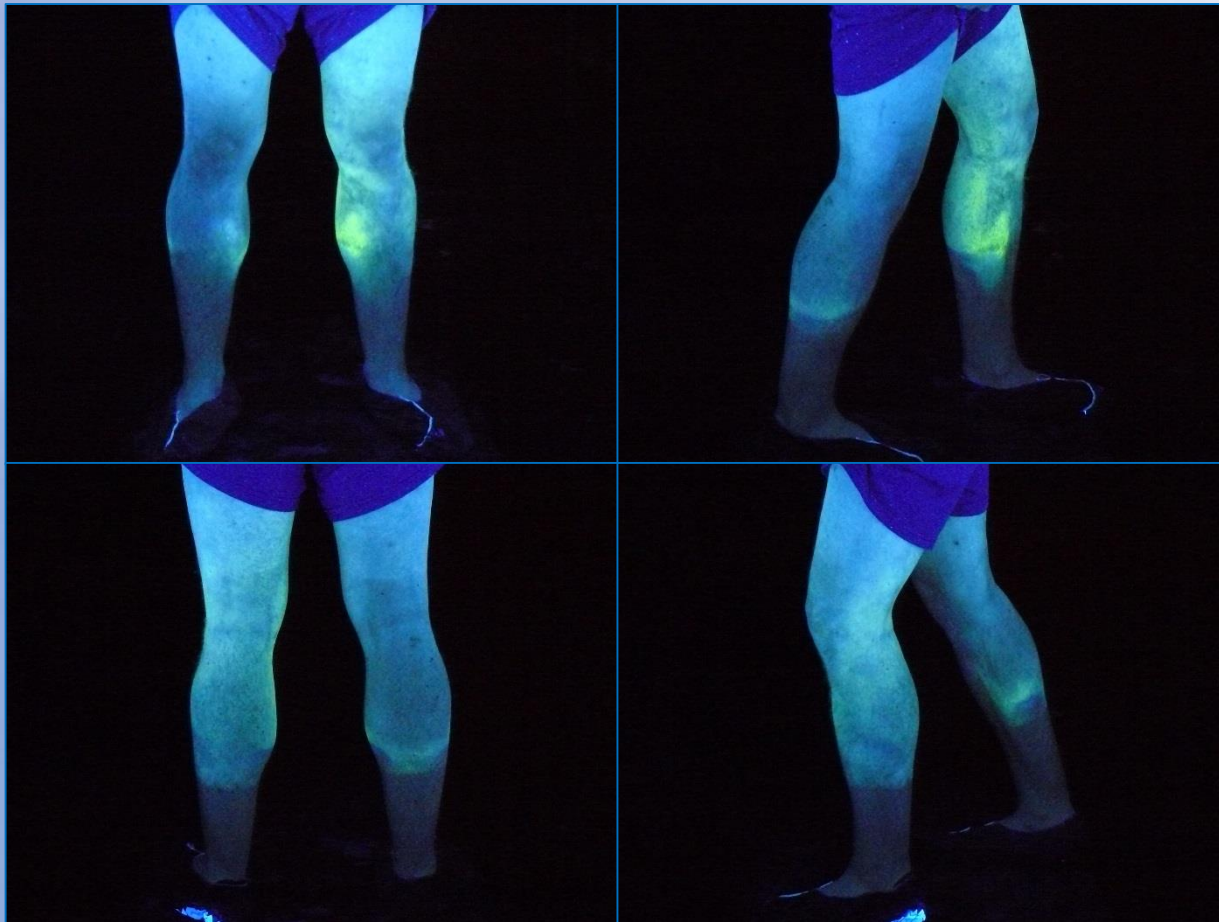
## UV Photos: Legs (Test # 2225, TP #7)

The lower legs had a high level of deposited aerosol. The patterns suggest aerosol infiltration through the boot-trouser interface and possible penetration through the trouser fabric.
