Pro Rescue Services

TRENCH SAFETY AWARENESS

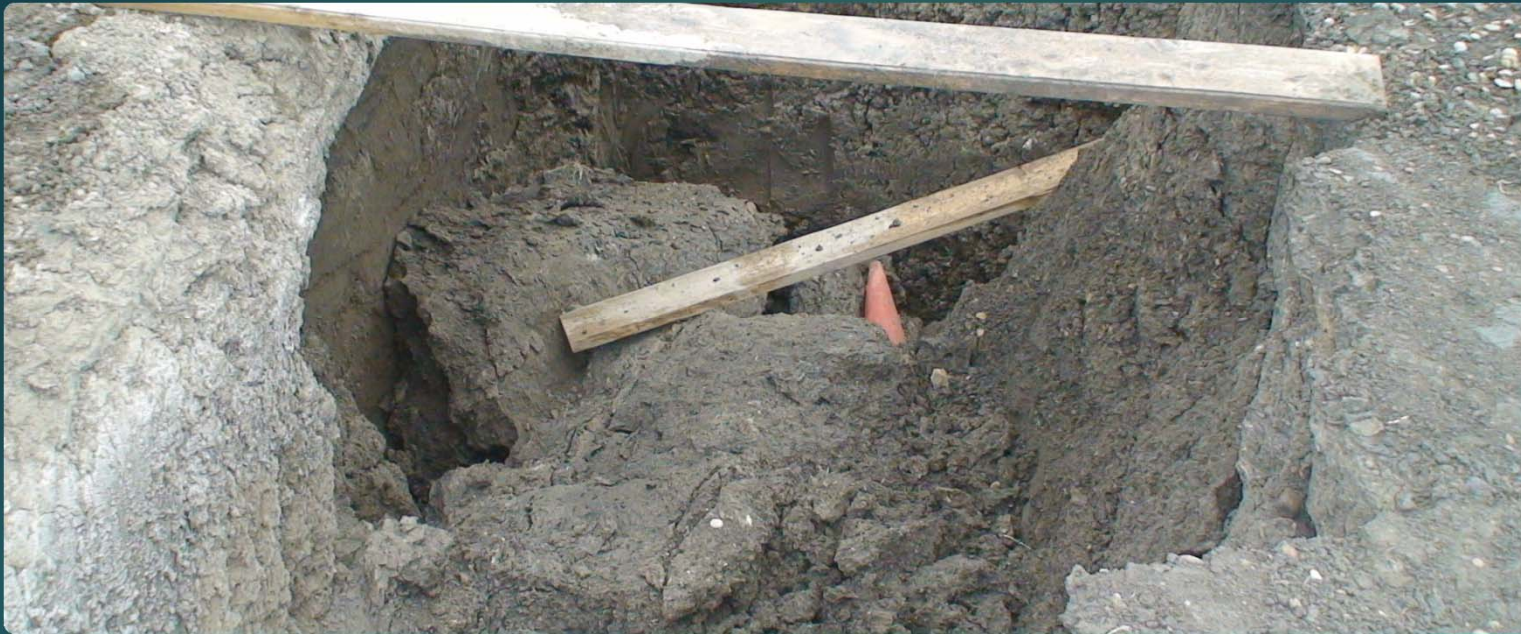
Examples of trench/excavation collapse

Sheer Wall Collapse

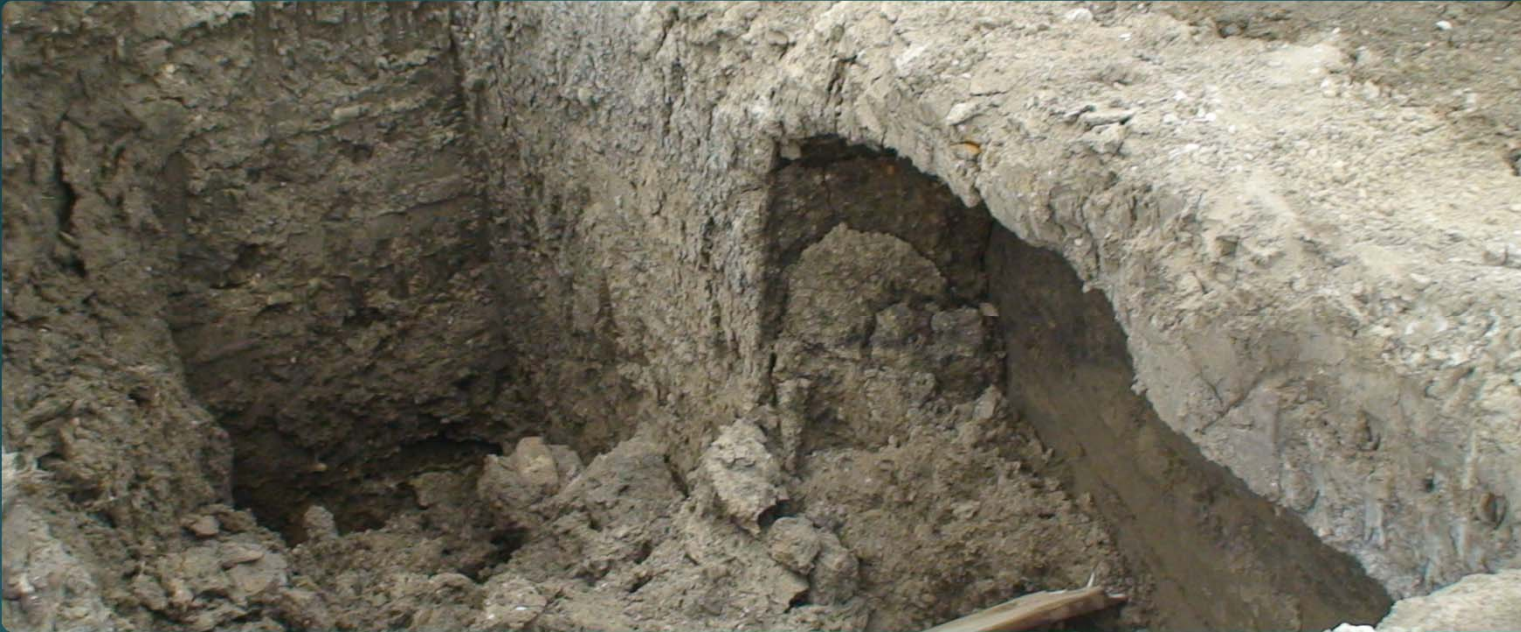
Examples of trench/excavation collapse

Slough In Collapse

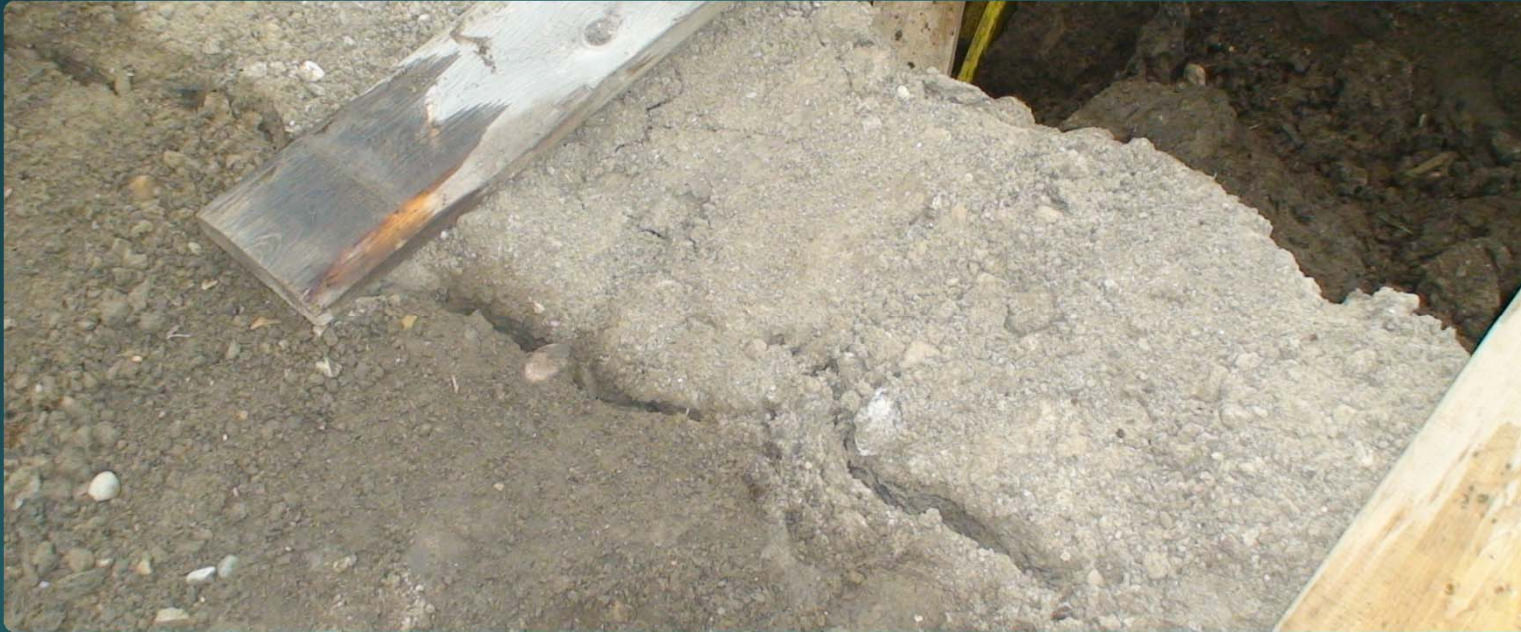
Examples of trench/excavation collapse

Trench Wall Crack

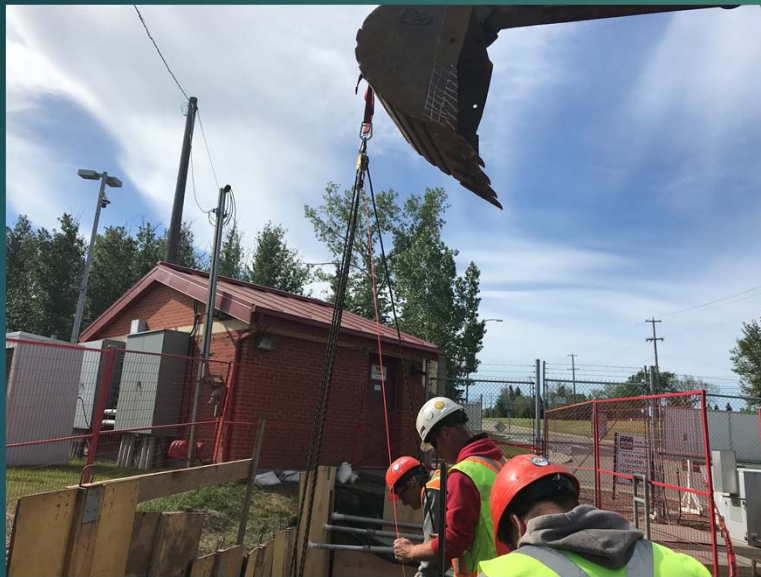
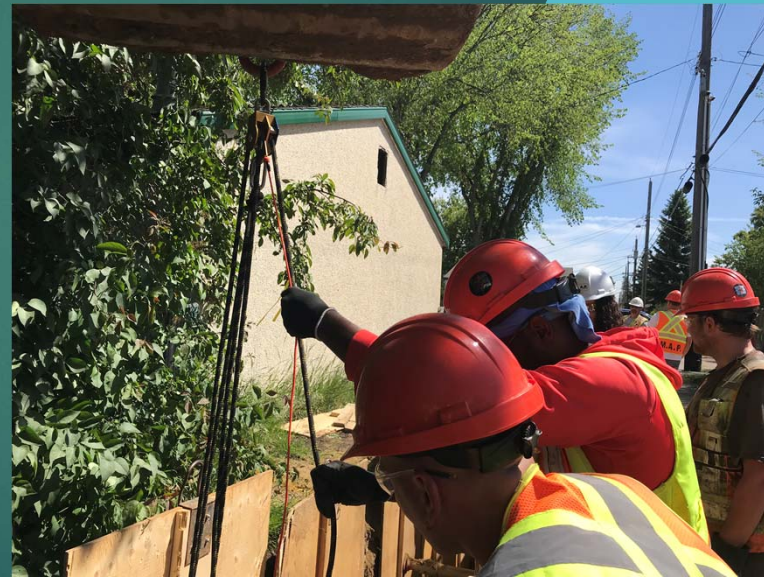
Rope Rescue System

Not intended for rescue from “collapsed trench”!

Some had equipment for rescue from shored trench, some did not. In all cases there were not adequate plans established for rescue.

Training centered around how to get injured worker out, how to safe out the area to ensure no damage to trench during emergency, how to safe out equipment, control of general public in residential areas, assistance with responding municipal services.

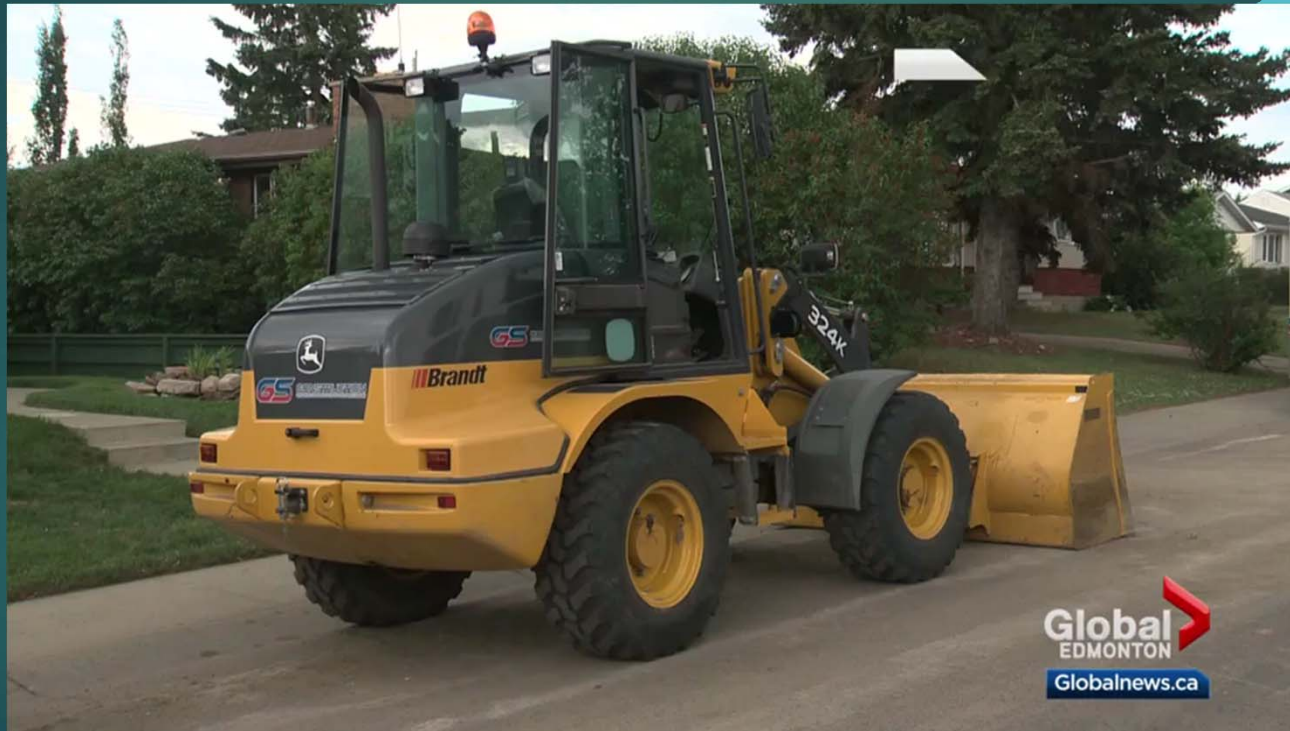
Trench Collapse Situation

A contractor was conducting hydrovac work on the edge of a shored trench. The trench section that workers were intended to enter and work inside, was protected by an engineered shoring box.

The hydrovac operator was standing on the outside of the shoring box, essentially on the edge of the excavation. The ground beneath the worker collapsed and the worker fell in and was completely covered.

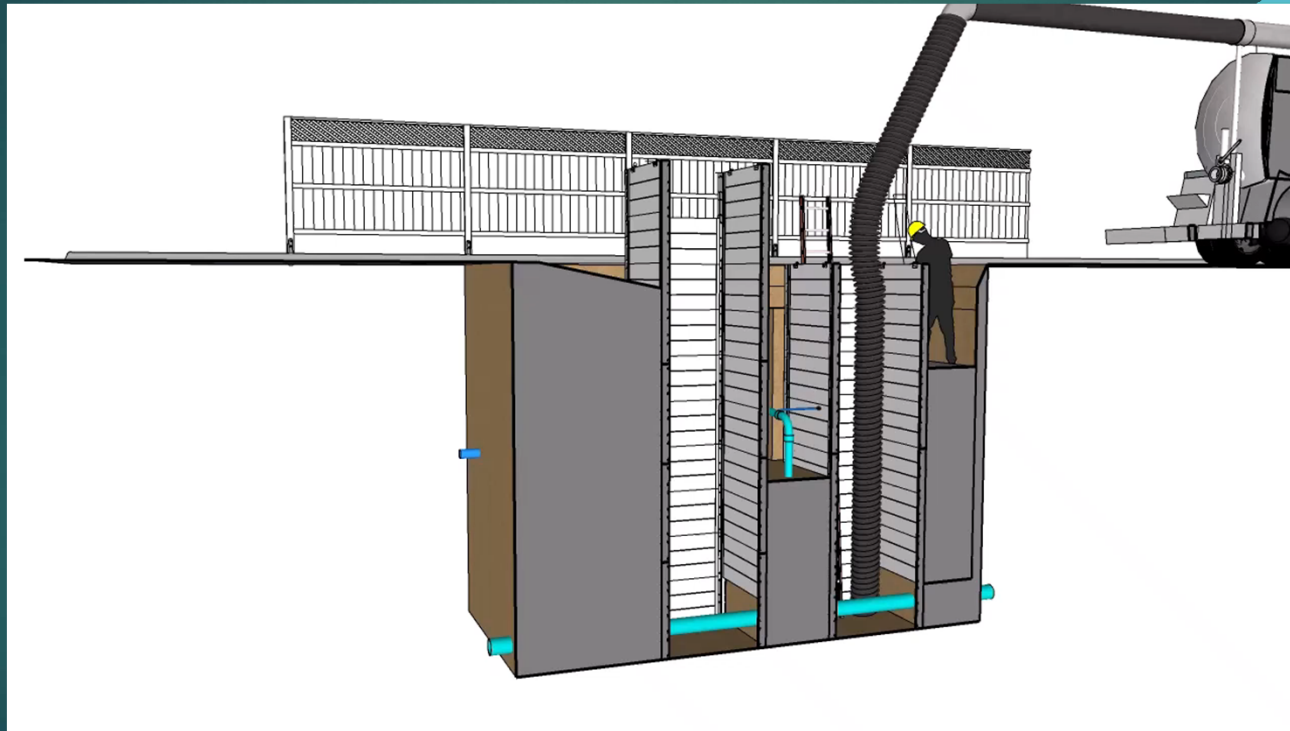
Re-creation of the Incident

Worker buried in trench collapse

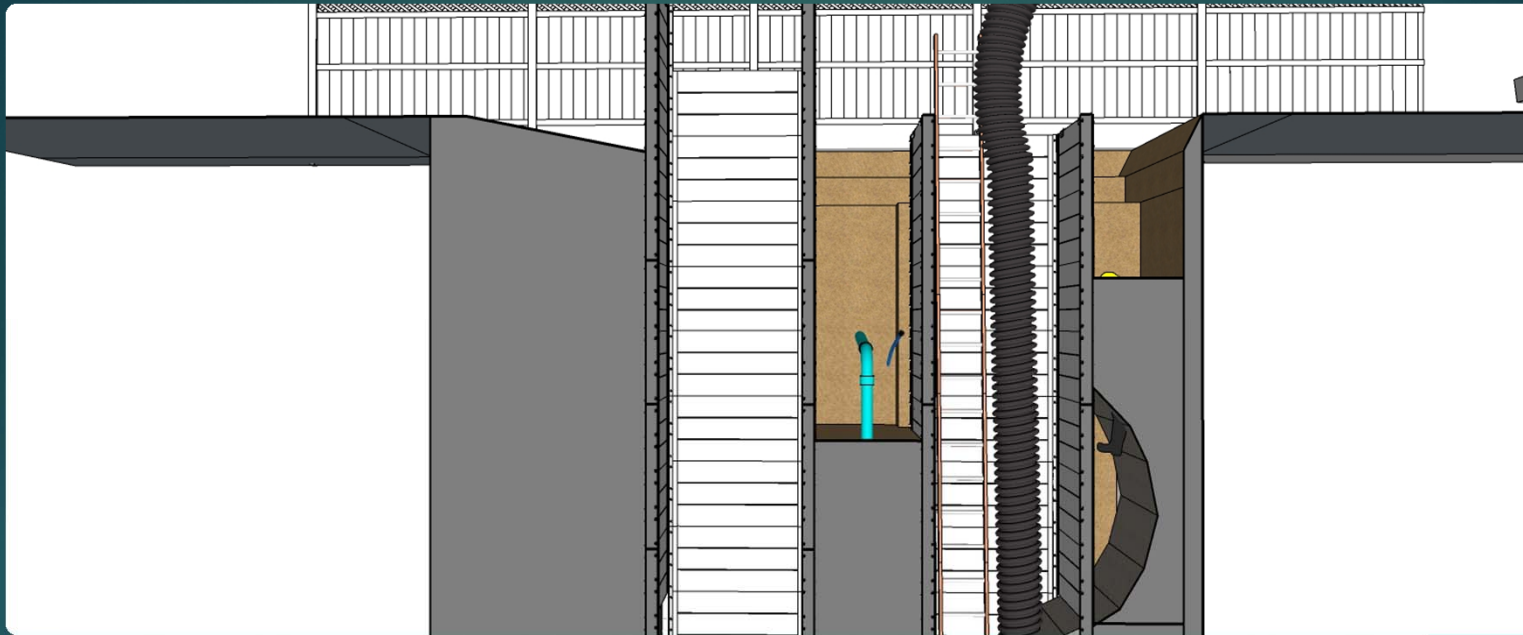
Void created from earth sloughing into the bottom of the shoring box

There were voids on the side of the shoring box and voids at the bottom of the shoring box which most likely led to the sloughing of material causing void for worker to fall into.

Void was left at the bottom of the box because of existing line. Could have been sheeted around and additional shoring strut installed. All voids are a potential location for trench collapse.
