# Fluorescent Aerosol Screening Test (FAST) Test Report

RTI Project Number: 0212534.112

January 7, 2015

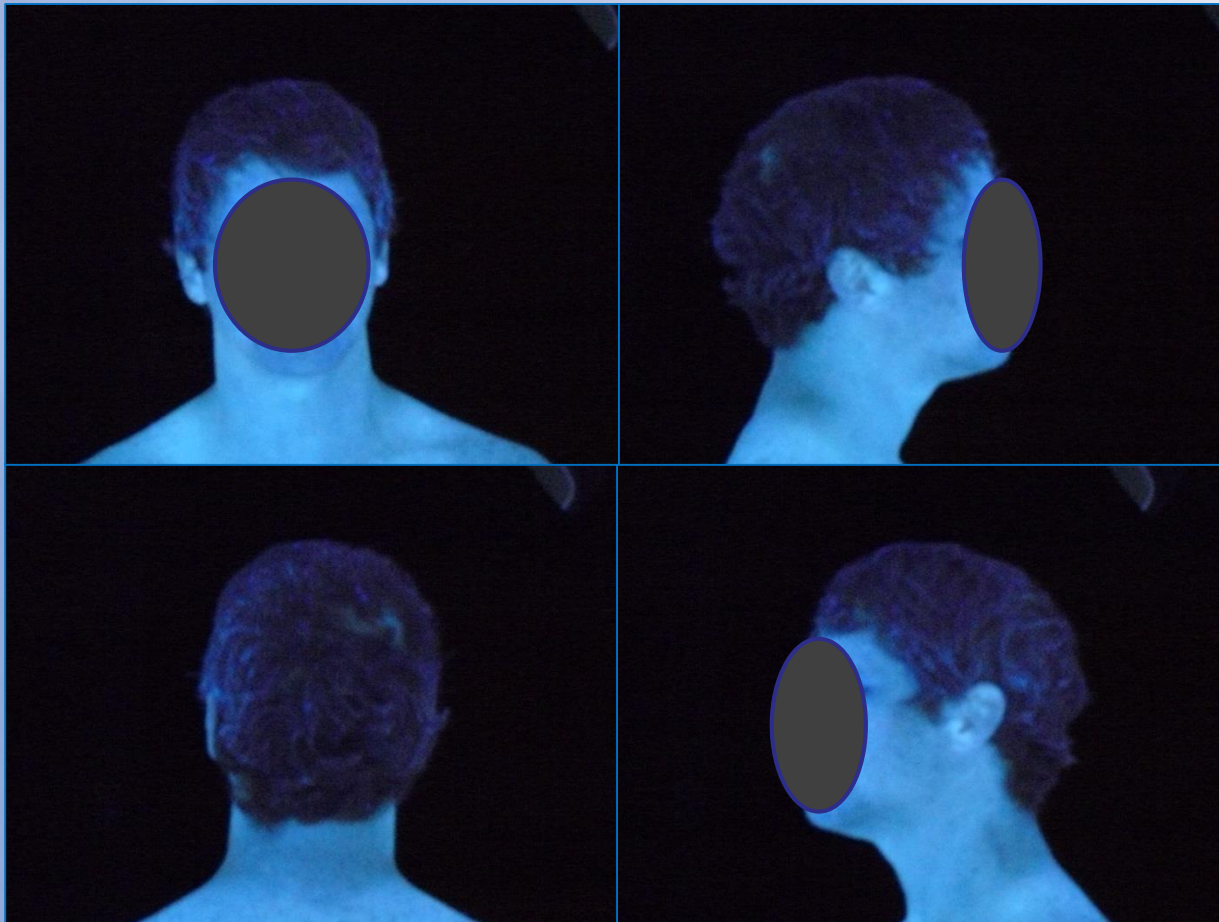
## Background UV Photos (Test Participant #7)

The background photos confirm the test participant was clean prior to donning the test garment.

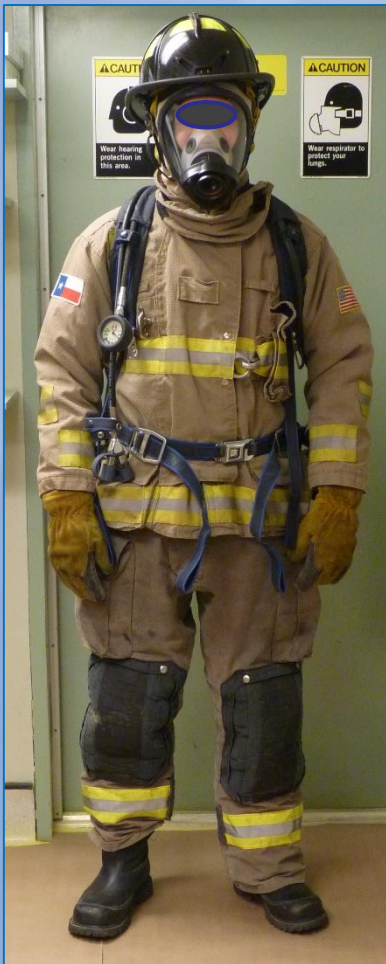
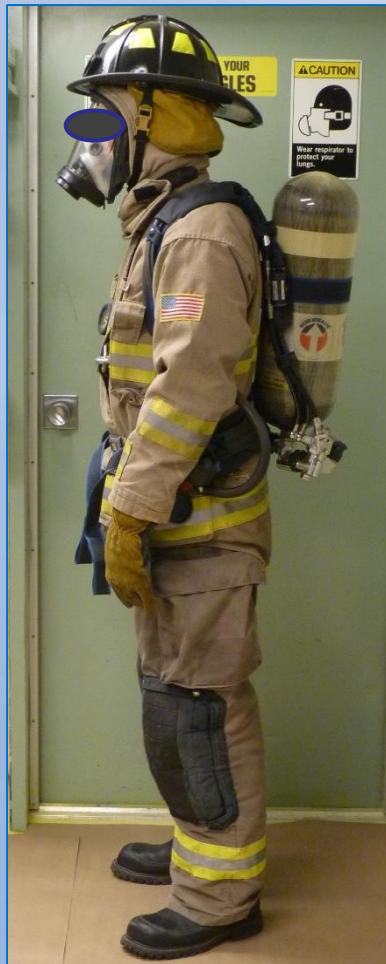
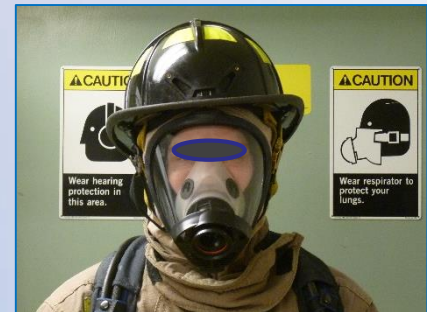
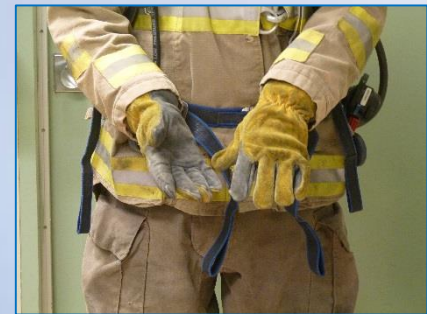
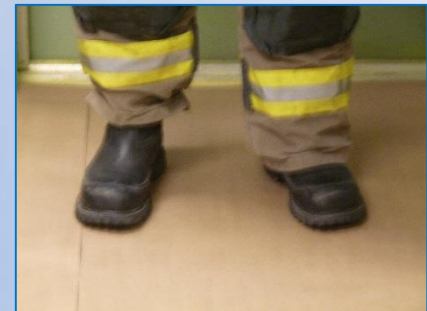
# Pre-Test Photos (RTI Test # 2225)

13 Pre-test photos were taken prior to wind tunnel entry. To preserve air in the tank, the SCBA regulator was not connected until immediately before wind tunnel entry.
